DESCRIPTION OF THE EXCAVATIONS

House 1

by J H Williams with F Williams

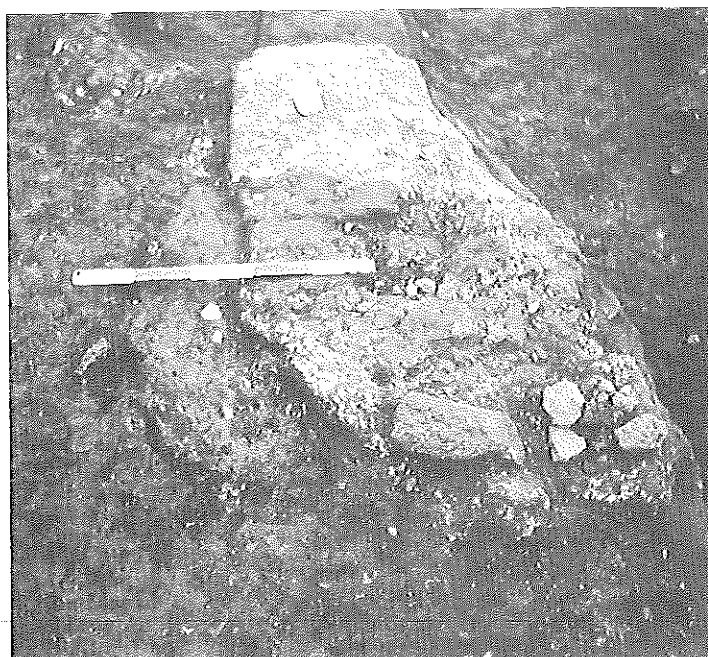
PLATE 3 House 1: Phase 4B iron-working furnace A460.

Phase 4B: Overlying building 1 and extending over much of the House 1 area was a very thin yellow green level 574. This should probably be seen as a floor level but the evidence for wall lines etc. is tenuous in the extreme. 574 does not occur to the west of easting 124 where a possible slot 658 and post-holes 656 and 657 follow a roughly north-south alignment. A northward continuation of this alignment was not traced, even though there is only limited disturbance in this area. It is, however, interesting to note the small patch of limestone metallurgy (589) to the west of (?) slot 658. All other walls of the presumed building (building 2) have been destroyed by later pitting. Associated with (?) floor 574 were two hearths, 460 and 584; little survived of hearth 460 but the quantity of slag in the immediate area suggests it was an iron-working furnace (see Fig. 10, Pl. 3 and below p. 278). No slag was found associated with hearth 584 or in the ash rake-out from it. Slag was found in pits 528 and 576 and the latter also contained large quantities of ash and a crucible fragment (Fig. 11). Pits in the area of House 8 (F70, 79, 207, 106, 202) may well have been contemporary and F70 is identified as a potential non-slag-tapping furnace (p. 278). It seems plausible that the excavated remains represent a workshop for iron and copper alloy with associated pits scattered round. Two Edmund Memorial pennies from layers A574 and A576 seem to indicate an early 10th century date (Nu8, 9).

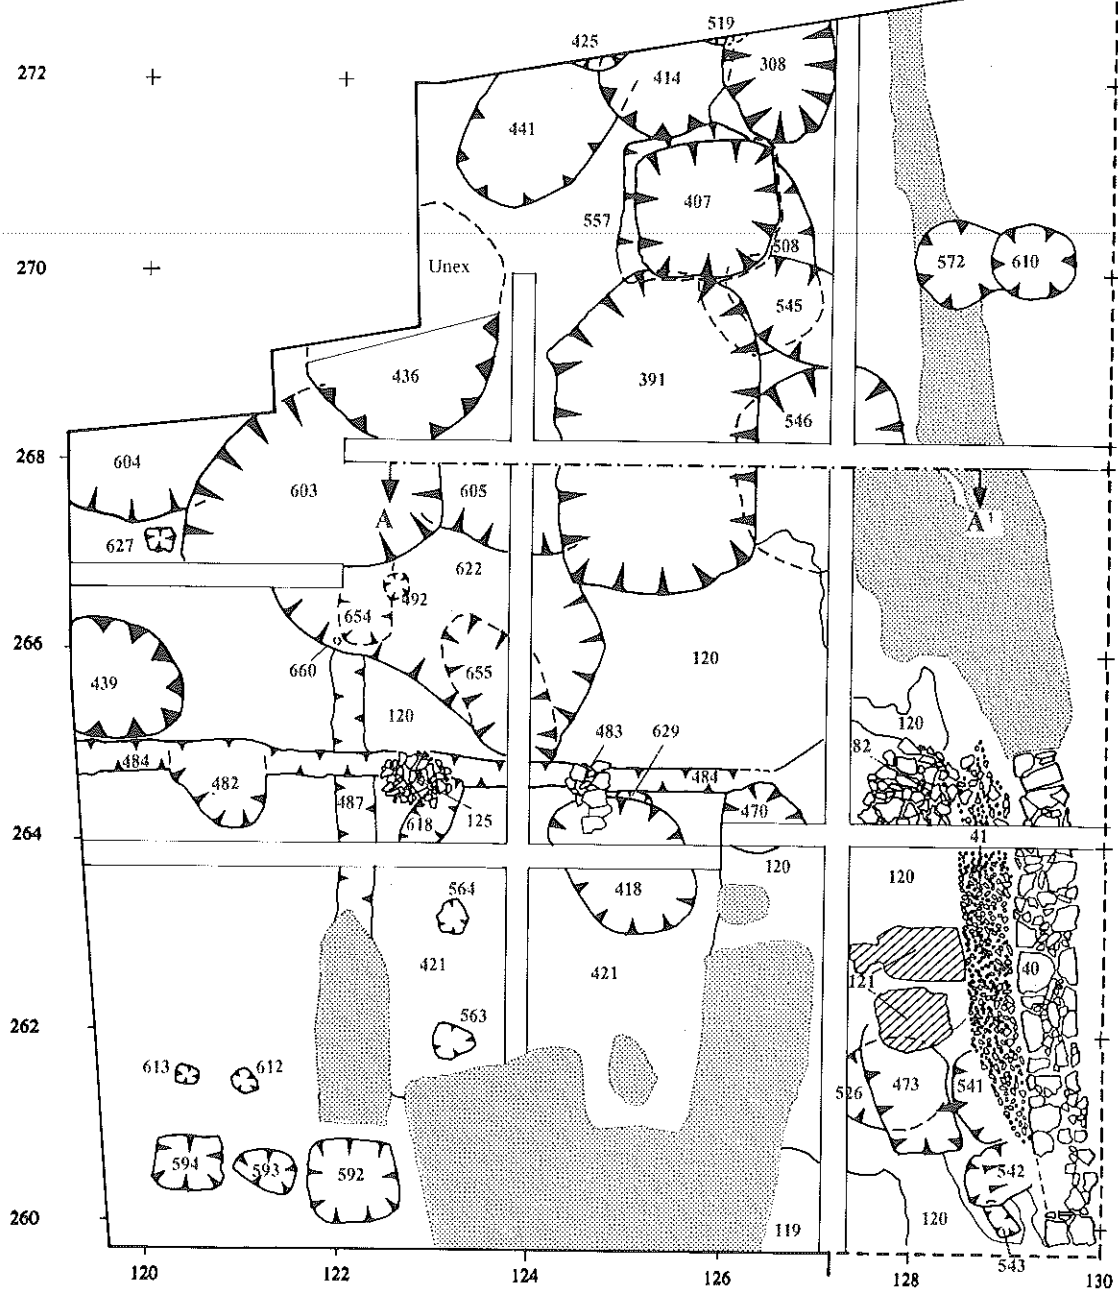
Fig 12

House 1 Phase 5

Phase 5 had a fairly long life, stone buildings probably not appearing until the total rebuilding of the street c. 1410-20. Hearth 82 is overlaid by wall 15 and in turn is later than the limestone scatter 41 regarded as packing for the wall trench of wall 40, which was part of the first stone structure of House 2. The stones of 41, immediately adjacent to 82, are also burnt. There is some problem, however, in relating 82 to the timber buildings. Slot 484 does not extend so far east and 82 is central to its alignment. How pits 541 etc. at the east end of the site fitted into Phase 5 is also unclear.

(15) extended virtually the whole length of the plot and seemed to disappear under the western baulk, perhaps indicating that the total extent of the house was not excavated. This is perhaps confirmed by the break in the west wall 92 where clay floor 217 is present; this is possibly a doorway. A further doorway leading from the house to the yard area was probably located on the line of wall 15 immediately to the west of wall 13 where the surface of wall 15 had a smooth worn appearance.

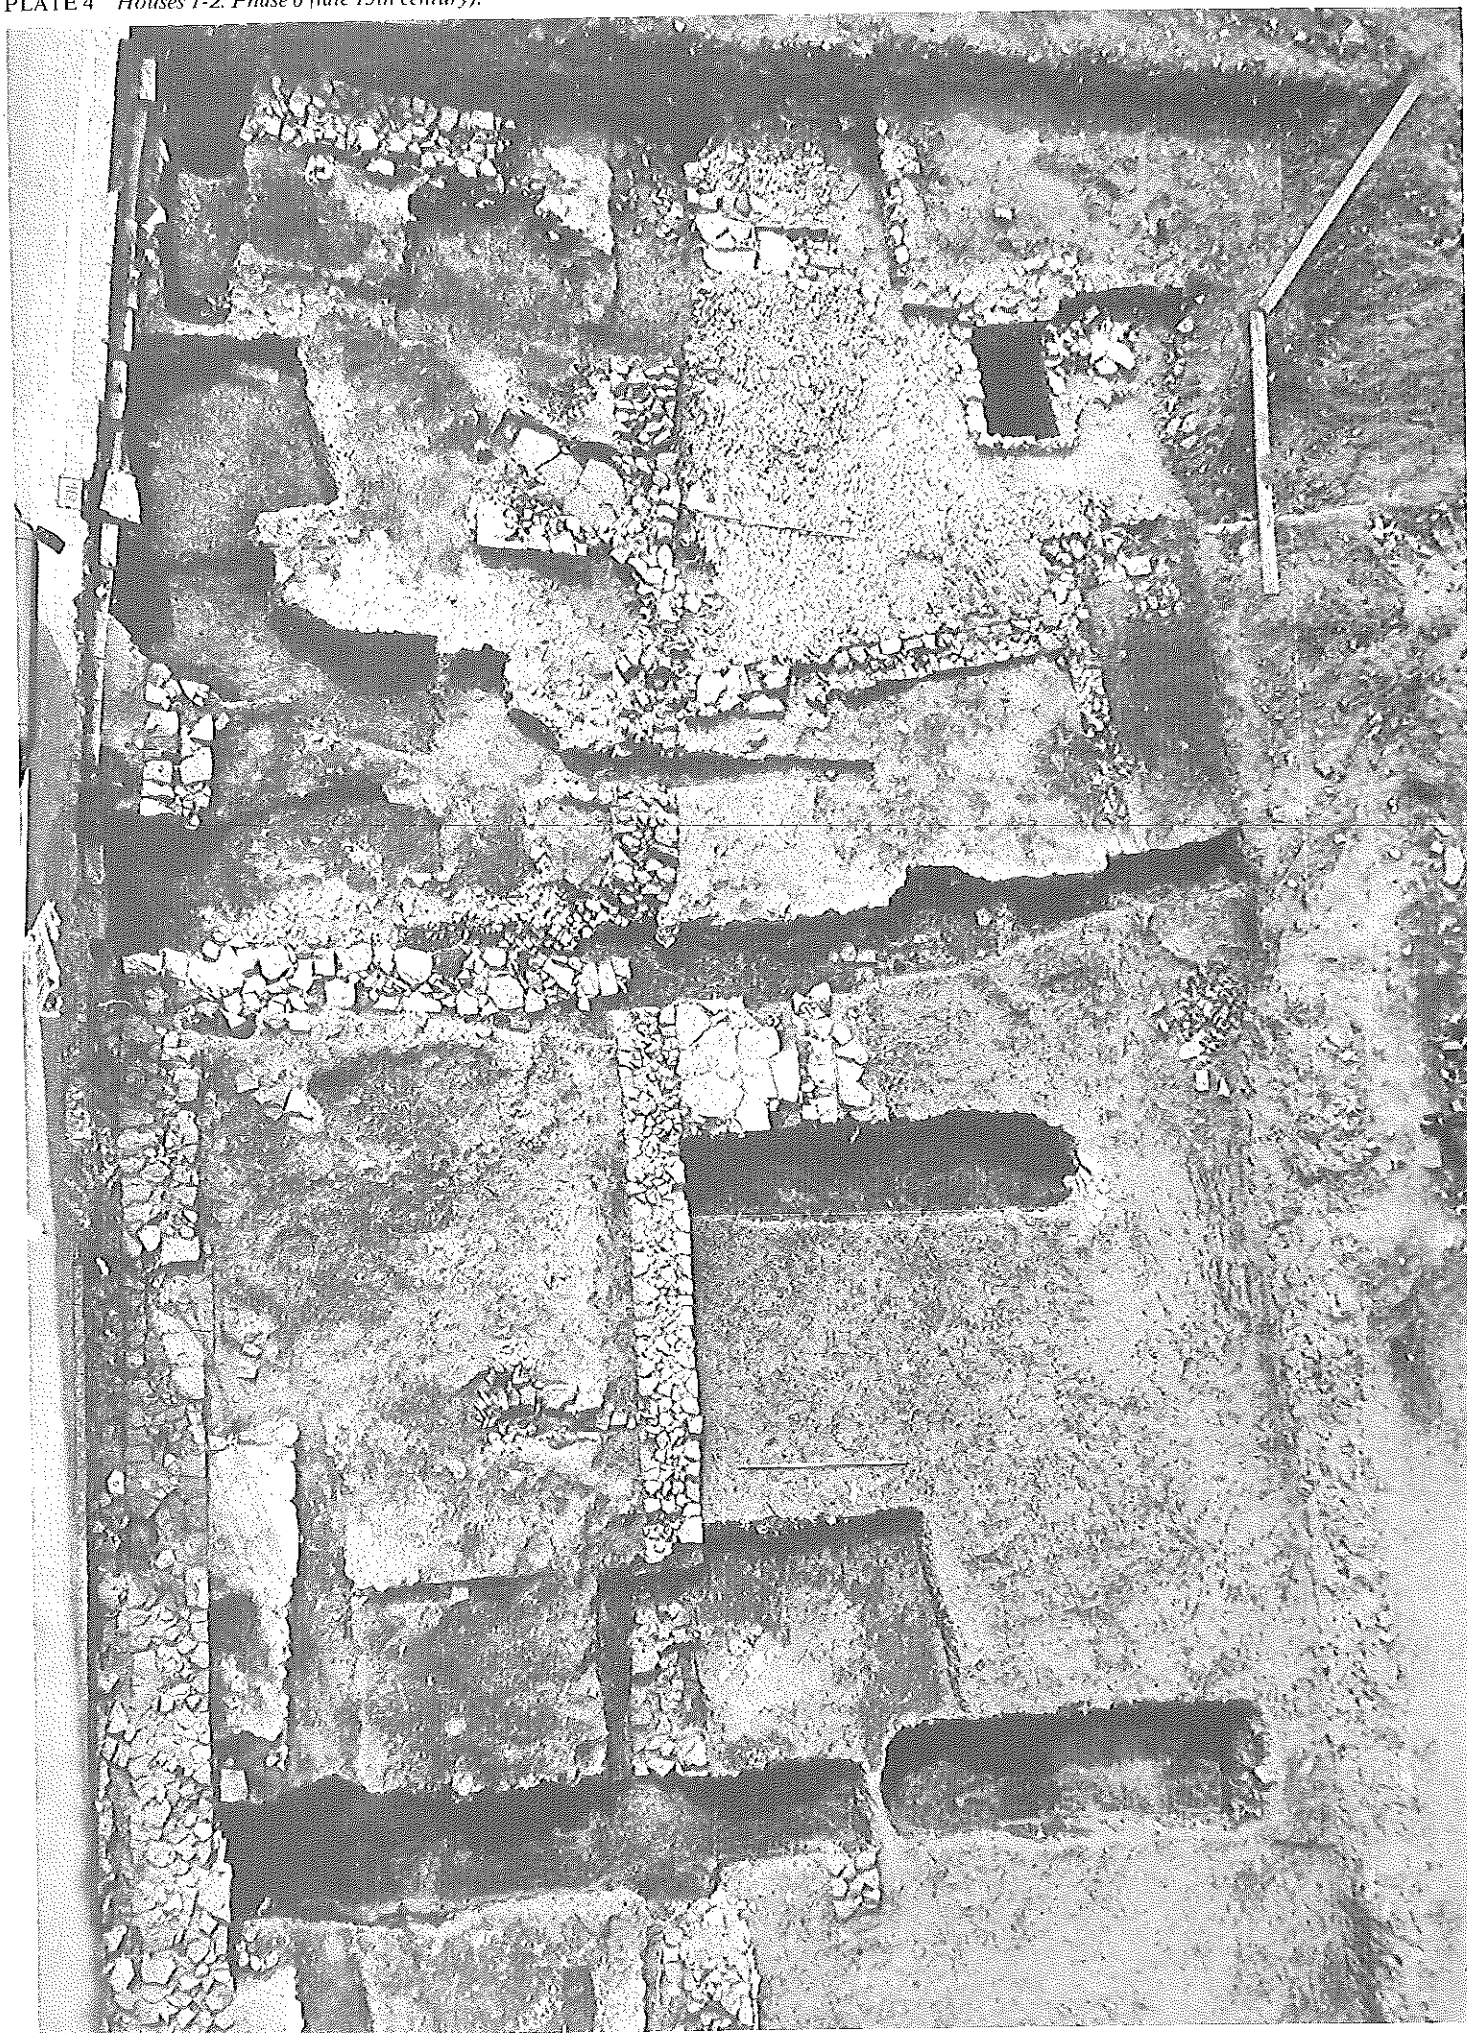
PLATE 4 *Houses 1-2: Phase 6 (late 15th century).*
